**Flood Control Project Maintenance
Levee Inspections**

Maintenance Issue Types Only, Levee Inspection Report By Mile - Spring 2019

Sutter Maintenance Yard Maintenance Area 0012

Waterway	Bank	Unit Miles	Inspection Start/End	Inspector
Unit No. 01 Colusa Drain	Left	11.06	04/08/2019 04/08/2019	Zach Jojola

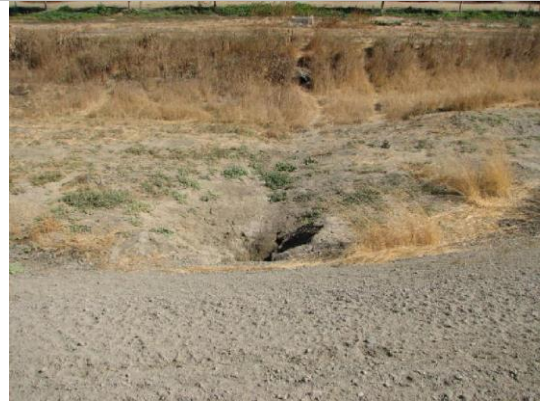
Photo 1 of 3 : UCIP_SP_2019_51779_68973.jpg

Comment Code						
Inspector Comment						
FS_ID:51779 DS_ID:17146 EP_NO: 9382 Repair Type: Non-Urgent Crossing Status: Found UCIP Comments: 5/2/2017 WS is in good condition. LS inlet is more than 50% full of sediment. Pipe needs to be cleaned internally. (DWR Sutter Yard- AFreitag)10/17/2016 MInor sediment blocking the WS flap gate from opening. LS inlet still mostly full of sediment.(DWR Sutter Yard- AFreitag)9/29/2016 Crossing has been downgraded from Urgent to Non-Urgent WS flap gate is closed for flood season. Need to coordinate with owner to remove sediment blocking WS flap gate. (DWR UCIP - omagana)5/31/2016 WS flap gate is blocked from opening by sediment. LS inlet is over 50% full of sediment. (DWR Sutter Yard - afreitag)5/4/2015 WS flap gate is blocked by sediment and unable to open. LS inlet is about 50% plugged with soil. Needs to be cleaned. (DWR Sutter Yard - afreitag)6/17/2014 Same as last inspection. (DWR Sutter Yard - afreitag)12/16/2013 Sediment against flapgate has been cleared and it can now function properly. (DWR Sutter Yard - afreitag)7/16/2013 Sediment is built up against WS flapgate preventing it from opening. (DWR Sutter Yard - afreitag)10/11/2012 Pipe is partially filled with soil. (DWR UCIP - wwylie) FIELD_STRUCT_DESC: 24-inch corrugated metal drainage pipe through the levee, 13 feet below the crown. Flap gate, concrete headwall, and grouted cobble spillway on the waterside (WS). Concrete headwall on the landside (LS). (24-inch pipe authorized under Automatic Board Order (ABO) issued as Permit No. 9385, 1974 - Jackson S. King). [Additional Reference(s): DWR Levee Log references ABO 9382, 2005. USACE Sacramento O&M Manual 132, October 1959, (HLM 0.49, Drawing No. 50-4-3081)]. FS Date: 5/2/2017 1:38:42 PM

Intake at LS toe.

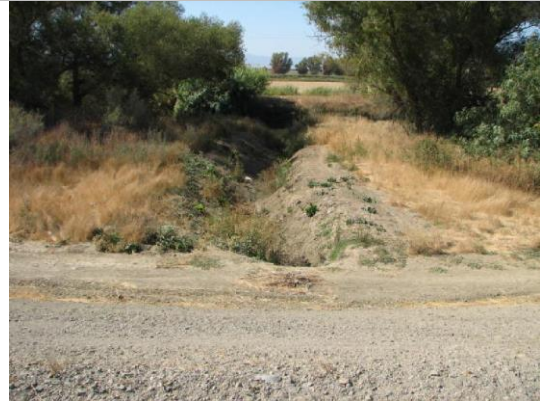
Photo 2 of 3 : UCIP_SP_2019_51779_68972.jpg

Comment Code						
Inspector Comment						
FS_ID:51779 DS_ID:17146 EP_NO: 9382 Repair Type: Non-Urgent Crossing Status: Found UCIP Comments: 5/2/2017 WS is in good condition. LS inlet is more than 50% full of sediment. Pipe needs to be cleaned internally. (DWR Sutter Yard- AFreitag)10/17/2016 MInor sediment blocking the WS flap gate from opening. LS inlet still mostly full of sediment.(DWR Sutter Yard- AFreitag)9/29/2016 Crossing has been downgraded from Urgent to Non-Urgent WS flap gate is closed for flood season. Need to coordinate with owner to remove sediment blocking WS flap gate. (DWR UCIP - omagana)5/31/2016 WS flap gate is blocked from opening by sediment. LS inlet is over 50% full of sediment. (DWR Sutter Yard - afreitag)5/4/2015 WS flap gate is blocked by sediment and unable to open. LS inlet is about 50% plugged with soil. Needs to be cleaned. (DWR Sutter Yard - afreitag)6/17/2014 Same as last inspection. (DWR Sutter Yard - afreitag)12/16/2013 Sediment against flapgate has been cleared and it can now function properly. (DWR Sutter Yard - afreitag)7/16/2013 Sediment is built up against WS flapgate preventing it from opening. (DWR Sutter Yard - afreitag)10/11/2012 Pipe is partially filled with soil. (DWR UCIP - wwylie) FIELD_STRUCT_DESC: 24-inch corrugated metal drainage pipe through the levee, 13 feet below the crown. Flap gate, concrete headwall, and grouted cobble spillway on the waterside (WS). Concrete headwall on the landside (LS). (24-inch pipe authorized under Automatic Board Order (ABO) issued as Permit No. 9385, 1974 - Jackson S. King). [Additional Reference(s): DWR Levee Log references ABO 9382, 2005. USACE Sacramento O&M Manual 132, October 1959, (HLM 0.49, Drawing No. 50-4-3081)]. FS Date: 5/2/2017 1:38:42 PM

Outlet at WS toe.

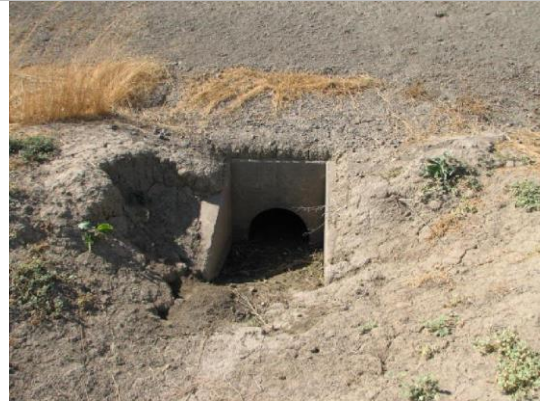
Photo 3 of 3 : UCIP_SP_2019_51779_68971.jpg

Comment Code						
Inspector Comment						
FS_ID:51779 DS_ID:17146 EP_NO: 9382 Repair Type: Non-Urgent Crossing Status: Found UCIP Comments: 5/2/2017 WS is in good condition. LS inlet is more than 50% full of sediment. Pipe needs to be cleaned internally. (DWR Sutter Yard- AFreitag)10/17/2016 MInor sediment blocking the WS flap gate from opening. LS inlet still mostly full of sediment.(DWR Sutter Yard- AFreitag)9/29/2016 Crossing has been downgraded from Urgent to Non-Urgent WS flap gate is closed for flood season. Need to coordinate with owner to remove sediment blocking WS flap gate. (DWR UCIP - omagana)5/31/2016 WS flap gate is blocked from opening by sediment. LS inlet is over 50% full of sediment. (DWR Sutter Yard - afreitag)5/4/2015 WS flap gate is blocked by sediment and unable to open. LS inlet is about 50% plugged with soil. Needs to be cleaned. (DWR Sutter Yard - afreitag)6/17/2014 Same as last inspection. (DWR Sutter Yard - afreitag)12/16/2013 Sediment against flapgate has been cleared and it can now function properly. (DWR Sutter Yard - afreitag)7/16/2013 Sediment is built up against WS flapgate preventing it from opening. (DWR Sutter Yard - afreitag)10/11/2012 Pipe is partially filled with soil. (DWR UCIP - wwylie) FIELD_STRUCT_DESC: 24-inch corrugated metal drainage pipe through the levee, 13 feet below the crown. Flap gate, concrete headwall, and grouted cobble spillway on the waterside (WS). Concrete headwall on the landside (LS). (24-inch pipe authorized under Automatic Board Order (ABO) issued as Permit No. 9385, 1974 - Jackson S. King). [Additional Reference(s): DWR Levee Log references ABO 9382, 2005. USACE Sacramento O&M Manual 132, October 1959, (HLM 0.49, Drawing No. 50-4-3081)]. FS Date: 5/2/2017 1:38:42 PM

Inlet and concrete headwall on LS toe.

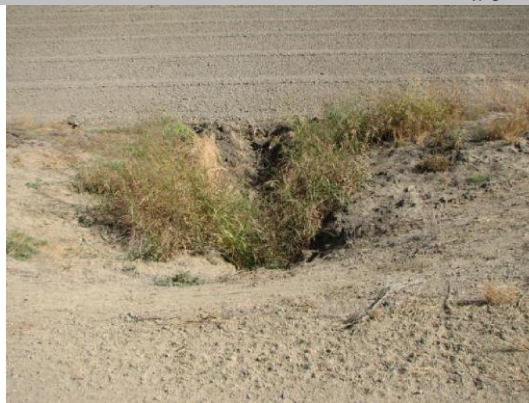
Photo 1 of 3 : UCIP_SP_2019_51780_68977.jpg

Comment Code					
Inspector Comment					
FS_ID:51780 DS_ID:17147 EP_NO: 9382 Repair Type: No Action Needed Crossing Status: Found UCIP Comments: 5/2/2017 Crossing appears to be in good condition. (DWR Sutter Yard- AFreitag)10/17/2016 Crossing appears to be in good condition. This is a gravity for the LS.(DWR Sutter Yard- AFreitag)5/31/2016 Crossing appears to be in good condition.5/4/2015 Crossing is in good condition. No issues.6/17/2014 Same as last inspection.12/16/2013 Same as last inspection.7/16/2013 Same as last inspection. FIELD_STRUCT_DESC: 24-inch corrugated metal drainage pipe through the levee, 13 feet below the crown. Flap gate, concrete headwall, and grouted cobble spillway on the waterside (WS). Concrete headwall on the landside (LS). (24-inch pipe [HLM 1.40] authorized under Automatic Board Order (ABO) issued as Permit No. 9382, 1974 - Olen C. Bober). [Additional Reference(s): DWR Levee Log, 2005. USACE Sacramento O&M Manual 132, October 1959, (HLM 1.4)]. FS Date: 5/2/2017 1:40:20 PM

Intake on LS toe.

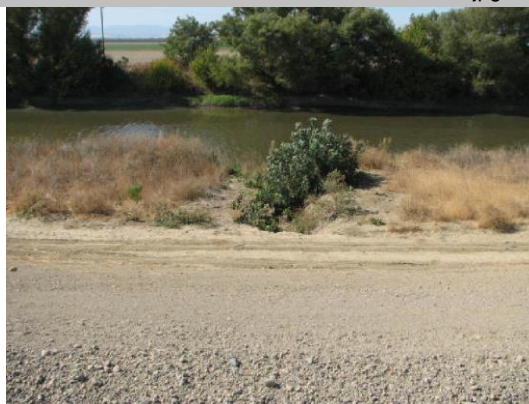
Photo 2 of 3 : UCIP_SP_2019_51780_68976.jpg

Outlet at WS toe.

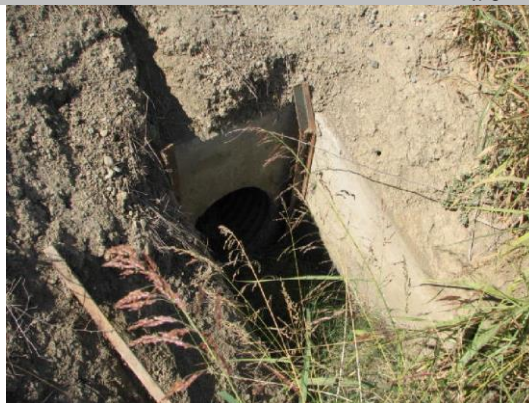
Photo 3 of 3 : UCIP_SP_2019_51780_68975.jpg

Comment Code						
Inspector Comment						
FS_ID:51780 DS_ID:17147 EP_NO: 9382 Repair Type: No Action Needed Crossing Status: Found UCIP Comments: 5/2/2017 Crossing appears to be in good condition. (DWR Sutter Yard- AFreitag)10/17/2016 Crossing appears to be in good condition. This is a gravity for the LS.(DWR Sutter Yard- AFreitag)5/31/2016 Crossing appears to be in good condition.5/4/2015 Crossing is in good condition. No issues.6/17/2014 Same as last inspection.12/16/2013 Same as last inspection.7/16/2013 Same as last inspection. FIELD_STRUCT_DESC: 24-inch corrugated metal drainage pipe through the levee, 13 feet below the crown. Flap gate, concrete headwall, and grouted cobble spillway on the waterside (WS). Concrete headwall on the landside (LS). (24-inch pipe [HLM 1.40] authorized under Automatic Board Order (ABO) issued as Permit No. 9382, 1974 - Olen C. Bober). [Additional Reference(s): DWR Levee Log, 2005. USACE Sacramento O&M Manual 132, October 1959, (HLM 1.4)]. FS Date: 5/2/2017 1:40:20 PM

Concrete U shaped headwall on LS toe.

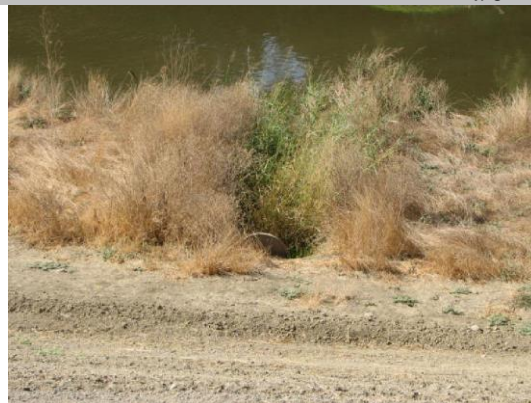
Photo 1 of 3 : UCIP_SP_2019_51782_68984.jpg

FS_ID:51782
DS_ID:17149
EP_NO: 9382
Repair Type: Non-Urgent
Crossing Status: Found
UCIP Comments: 5/2/2017 WS flapgate buried by sediment. Needs to be dug out. (DWR Sutter Yard- AFreitag)10/17/2016 Crossing appears to be in good condition. This is a gravity drain for the LS. (DWR Sutter Yard- AFreitag)5/31/2016 LS inlets was partially plugged. WS flapgate was clear of sediment and abale to operate properly.5/4/2015 WS flapgate is blocked by sediment and unable to open. LS inlet is plugged by silt and wood chippings. Needs to be cleaned.6/17/2014 Flap gate was cleaned out and is fully closed. LS inlet still partially full of soil.12/16/2013 Same as last inspection. WS flapgate still needs to be cleaned out and shut.7/16/2013 Same as last inspection. Make sure flapgate is closed before highwater season.10/11/2012 Inlet on LS filled partially with soil. Outlet blocked with soil and the flap gate wont close.

Outlet on WS toe.

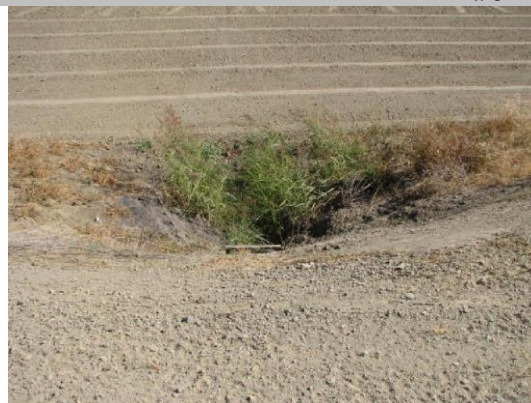
Photo 2 of 3 : UCIP_SP_2019_51782_68983.jpg

Inlet on LS toe.

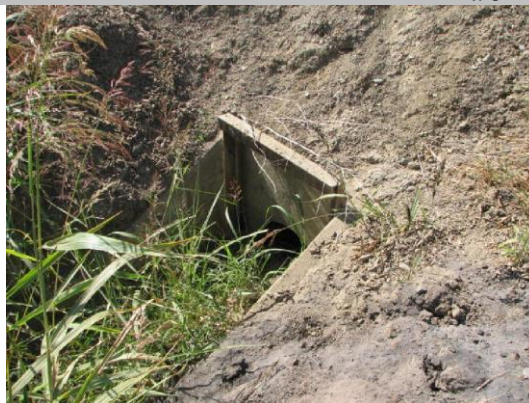
Photo 3 of 3 : UCIP_SP_2019_51782_68982.jpg

Comment Code						
Inspector Comment						
FS_ID:51782 DS_ID:17149 EP_NO: 9382 Repair Type: Non-Urgent Crossing Status: Found UCIP Comments: 5/2/2017 WS flapgate buried by sediment. Needs to be dug out. (DWR Sutter Yard- A Freitag)10/17/2016 Crossing appears to be in good condition. This is a gravity drain for the LS. (DWR Sutter Yard- A Freitag)5/31/2016 LS inlets was partially plugged. WS flapgate was clear of sediment and abale to operate properly.5/4/2015 WS flapgate is blocked by sediment and unable to open. LS inlet is plugged by silt and wood chippings. Needs to be cleaned.6/17/2014 Flap gate was cleaned out and is fully closed. LS inlet still partially full of soil.12/16/2013 Same as last inspection. WS flapgate still needs to be cleaned out and shut.7/16/2013 Same as last inspection. Make sure flapgate is closed before highwater season.10/11/2012 Inlet on LS filled partially with soil. Outlet blocked with soil and the flap gate wont close. FIELD_STRUCT_DESC: 24-inch corrugated metal drainage pipe through the levee, 13 feet below the crown. Flap gate, concrete headwall, and grouted cobble spillway on the waterside (WS). Concrete headwall on the landside (LS). (24-inch pipe [HLM 1.72] authorized under Automatic Board Order (ABO) issued as Permit No. 9382, 1974 - Olen C. Bober). [Additional Reference(s): DWR Levee Log, 2005. USACE Sacramento O&M Manual 132, October 1959, (HLM 1.72)]. FS Date: 5/2/2017 1:50:52 PM

Concrete U shaped headwall at LS inlet.

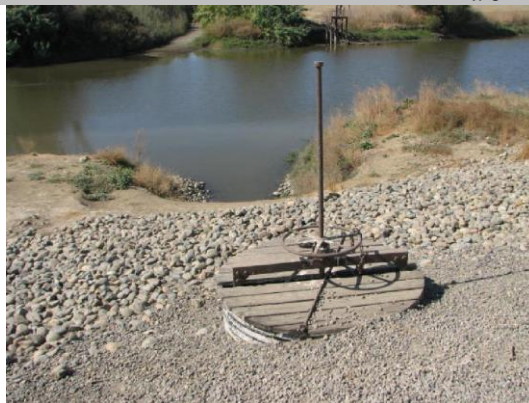
Photo 1 of 3 : UCIP_SP_2019_51785_68991.jpg

FS_ID:51785
DS_ID:17150
EP_NO: 9387
Repair Type: No Action Needed
Crossing Status: Found
UCIP Comments: 5/2/2017 Crossing appears to be in good condition. (DWR Sutter Yard- AFreitag)10/17/2016 Crossing appears to be in good condition. (DWR Sutter Yard- AFreitag)5/31/2016 Crossing appears to be in good condition. Attached photo showing location of LS inlet.5/4/2015 WS flapgate mostly underwater but could tell it was blocked open by something. LS inlet is located about 1/4 mile north along the side of the roadway.6/17/2014 Same as last inspection.12/16/2013 Pipe was flowing water and flap gate was being pushed open. Cannot verify if it will close all the way.7/16/2013 Same as last inspection. Was told inlet is about 1/4 mile down road way next to house. Will try to get coordinates for inlet.10/11/2012 No inlet could be located on LS. Flap gate partially blocked and will not close completely.
FIELD_STRUCT_DESC: 48-inch corrugated metal drainage pipe through the levee, 20 feet below the crown. Slide gate in 60-inch riser on the waterside (WS) slope. Flap gate and concrete headwall on the WS. (48-inch pipe authorized under Automatic Board Order (ABO) issued as Permit No. 9387, 1974 - Lauretta S. Christenson). [Additional Reference(s): DWR Levee Log, 2005. USACE Sacramento O&M Manual 132, October 1959, (HLM 1.8)].

60-inch standpipe with slide gate on WS slope with outlet in background.

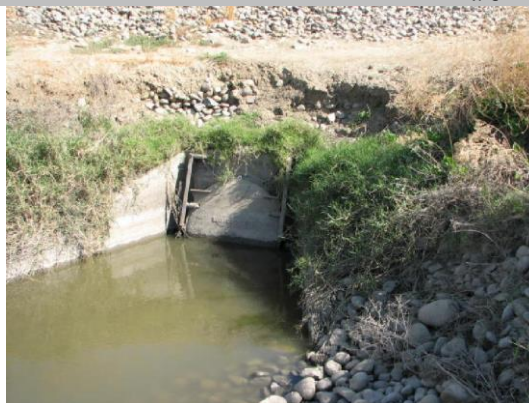
Photo 2 of 3 : UCIP_SP_2019_51785_68990.jpg

Flap gate and concrete headwall at WS toe.

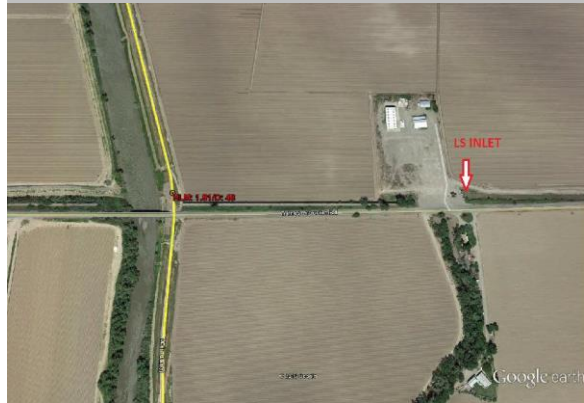
Photo 3 of 3 : UCIP_SP_2019_51785_75168.jpg

Comment Code						
Inspector Comment						
FS_ID:51785 DS_ID:17150 EP_NO: 9387 Repair Type: No Action Needed Crossing Status: Found UCIP Comments: 5/2/2017 Crossing appears to be in good condition. (DWR Sutter Yard- AFreitag)10/17/2016 Crossing appears to be in good condition. (DWR Sutter Yard- AFreitag)5/31/2016 Crossing appears to be in good condition. Attached photo showing location of LS inlet.5/4/2015 WS flapgate mostly underwater but could tell it was blocked open by something. LS inlet is located about 1/4 mile north along the side of the roadway.6/17/2014 Same as last inspection.12/16/2013 Pipe was flowing water and flap gate was being pushed open. Cannot verify if it will close all the way.7/16/2013 Same as last inspection. Was told inlet is about 1/4 mile down road way next to house. Will try to get coordinates for inlet.10/11/2012 No inlet could be located on LS. Flap gate partially blocked and will not close completely. FIELD_STRUCT_DESC: 48-inch corrugated metal drainage pipe through the levee, 20 feet below the crown. Slide gate in 60-inch riser on the waterside (WS) slope. Flap gate and concrete headwall on the WS. (48-inch pipe authorized under Automatic Board Order (ABO) issued as Permit No. 9387, 1974 - Lauretta S. Christenson). [Additional Reference(s): DWR Levee Log, 2005. USACE Sacramento O&M Manual 132, October 1959, (HLM 1.8)]. FS Date: 5/2/2017 1:56:07 PM

Arrow showing location of LS inlet

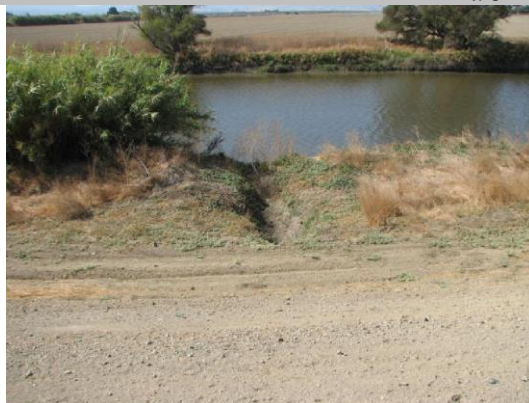
Photo 1 of 3 : UCIP_SP_2019_51786_68994.jpg

FS_ID:51786
DS_ID:17151
EP_NO: 9391
Repair Type: Non-Urgent
Crossing Status: Found
UCIP Comments: 5/2/2017 Both ends of pipe buried. (DWR Sutter Yard- AFreitag)10/17/2016 Appears abandoned. Both pipe ends are completely buried. (DWR Sutter Yard- AFreitag)9/29/2016 Crossing has been downgraded from Urgent to Non-Urgent both pipe ends are buried. Having both ends buried prevents water from flowing from WS to LS during flood season. Need to contact owner and have owner coordinate with CVFPB to comply with Title 23. (DWR UCIP - omagana)5/31/2016 Both pipe ends are buried. Pipe is non-operational. (DWR Sutter Yard - afreitag)5/4/2015 LS and WS ends are blocked with soil. Pipe is inoperable as it is. (DWR Sutter Yard - afreitag)6/17/2014 Same as last inspection. (DWR Sutter Yard - afreitag)12/16/2013 Same as last inspection. (DWR Sutter Yard - afreitag)7/16/2013 LS inlet is completely filled with soil. Needs to be cleaned out. (DWR Sutter Yard - afreitag)10/11/2012 Inlet is partially filled with soil. (DWR Sutter Yard - wwylie)

WS view of outlet.

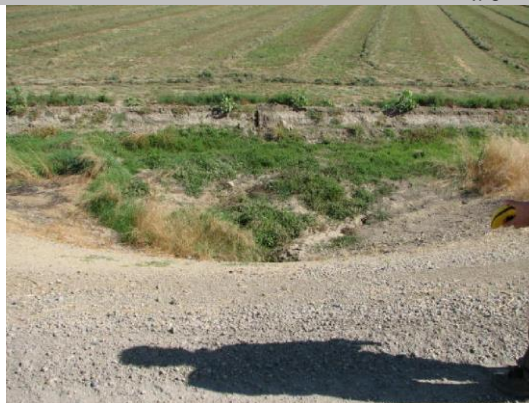
Photo 2 of 3 : UCIP_SP_2019_51786_68993.jpg

Comment Code						
Inspector Comment						
FS_ID:51786 DS_ID:17151 EP_NO: 9391 Repair Type: Non-Urgent Crossing Status: Found UCIP Comments: 5/2/2017 Both ends of pipe buried. (DWR Sutter Yard- AFreitag)10/17/2016 Appears abandoned. Both pipe ends are completely buried. (DWR Sutter Yard- AFreitag)9/29/2016 Crossing has been downgraded from Urgent to Non-Urgent both pipe ends are buried. Having both ends buried prevents water from flowing from WS to LS during flood season. Need to contact owner and have owner coordinate with CVFPB to comply with Title 23. (DWR UCIP - omagana)5/31/2016 Both pipe ends are buried. Pipe is non-operational. (DWR Sutter Yard - afreitag)5/4/2015 LS and WS ends are blocked with soil. Pipe is inoperable as it is. (DWR Sutter Yard - afreitag)6/17/2014 Same as last inspection. (DWR Sutter Yard - afreitag)12/16/2013 Same as last inspection. (DWR Sutter Yard - afreitag)7/16/2013 LS inlet is completely filled with soil. Needs to be cleaned out. (DWR Sutter Yard - afreitag)10/11/2012 Inlet is partially filled with soil. (DWR Sutter Yard - wylie) FIELD_STRUCT_DESC: *ABANDONED* 24-inch corrugated metal drainage pipe through the levee, 13 feet below the crown. Flap gate, concrete headwall, and grouted cobble spillway on the waterside (WS). Concrete headwall on the landside (LS). (24-inch pipe authorized under Automatic Board Order (ABO) issued as Permit No. 9391, 1974 - Department of Water Resources, Northern District). [Additional Reference(s): DWR Levee Log, 2005. USACE Sacramento O&M Manual 132, October 1959, (HLM 2.02)]. FS Date: 5/2/2017 2:01:25 PM

LS view of inlet.

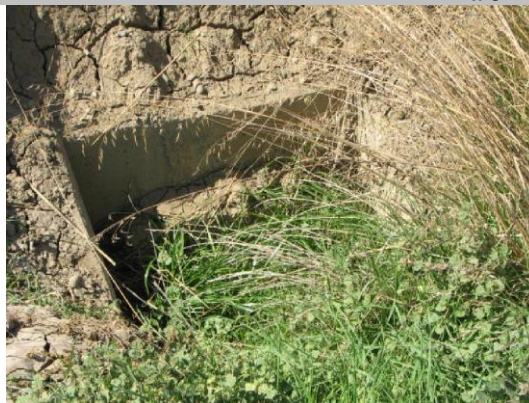
Photo 3 of 3 : UCIP_SP_2019_51786_68992.jpg

Comment Code						
Inspector Comment						
FS_ID:51786 DS_ID:17151 EP_NO: 9391 Repair Type: Non-Urgent Crossing Status: Found UCIP Comments: 5/2/2017 Both ends of pipe buried. (DWR Sutter Yard- AFreitag)10/17/2016 Appears abandoned. Both pipe ends are completely buried. (DWR Sutter Yard- AFreitag)9/29/2016 Crossing has been downgraded from Urgent to Non-Urgent both pipe ends are buried. Having both ends buried prevents water from flowing from WS to LS during flood season. Need to contact owner and have owner coordinate with CVFPB to comply with Title 23. (DWR UCIP - omagana)5/31/2016 Both pipe ends are buried. Pipe is non-operational. (DWR Sutter Yard - afreitag)5/4/2015 LS and WS ends are blocked with soil. Pipe is inoperable as it is. (DWR Sutter Yard - afreitag)6/17/2014 Same as last inspection. (DWR Sutter Yard - afreitag)12/16/2013 Same as last inspection. (DWR Sutter Yard - afreitag)7/16/2013 LS inlet is completely filled with soil. Needs to be cleaned out. (DWR Sutter Yard - afreitag)10/11/2012 Inlet is partially filled with soil. (DWR Sutter Yard - wwylie) FIELD_STRUCT_DESC: *ABANDONED* 24-inch corrugated metal drainage pipe through the levee, 13 feet below the crown. Flap gate, concrete headwall, and grouted cobble spillway on the waterside (WS). Concrete headwall on the landside (LS). (24-inch pipe authorized under Automatic Board Order (ABO) issued as Permit No. 9391, 1974 - Department of Water Resources, Northern District). [Additional Reference(s): DWR Levee Log, 2005. USACE Sacramento O&M Manual 132, October 1959, (HLM 2.02)]. FS Date: 5/2/2017 2:01:25 PM

Concrete U shaped headwall at LS toe.

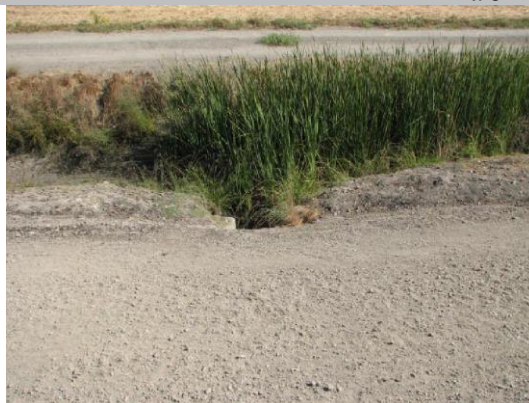
Photo 1 of 3 : UCIP_SP_2019_51788_69002.jpg

Comment Code					
Inspector Comment					
FS_ID:51788 DS_ID:17153 EP_NO: 9384 Repair Type: No Action Needed Crossing Status: Found UCIP Comments: 5/2/2017 Crossing appears to be in good condition. (DWR Sutter Yard- AFreitag)10/17/2016 Crossing appears to be in good condition. (DWR Sutter Yard- AFreitag)5/31/2016 Crossing appears to be in good condition.5/4/2015 Crossing appears in good condition. No noticeable issues.6/17/2014 Same as last inspection.12/16/2013 Same as last inspection.7/16/2013 Same as last inspection. FIELD_STRUCT_DESC: 24-inch corrugated metal drainage pipe through the levee, 16 feet below the crown. Flap gate, concrete headwall, and grouted cobble spillway on the waterside (WS). Concrete headwall on the landside (LS). (24-inch pipe [HLM 3.22] authorized under Automatic Board Order (ABO) issued as Permit No. 9384, 1974 - William D. Struckmeyer) [Additional Reference(s): DWR Levee Log, 2005. USACE Sacramento O&M Manual 132, October 1959, (HLM 3.22)]. FS Date: 5/2/2017 2:04:40 PM

Concrete headwall at LS toe.

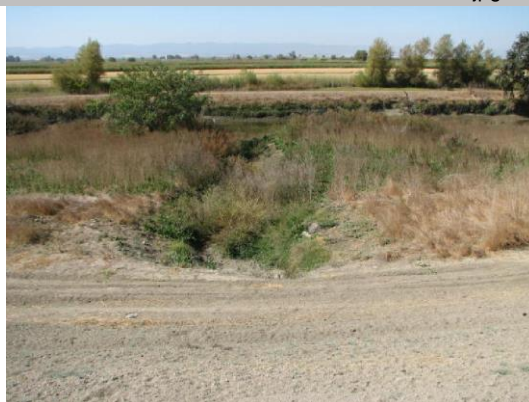
Photo 2 of 3 : UCIP_SP_2019_51788_69001.jpg

Drainage Swale on WS toe.

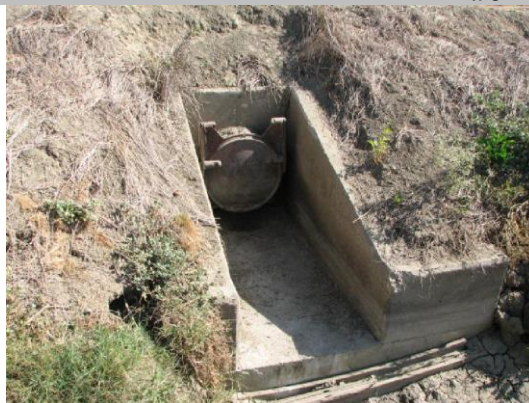
Photo 3 of 3 : UCIP_SP_2019_51788_69000.jpg

Comment Code						
Inspector Comment						
FS_ID:51788 DS_ID:17153 EP_NO: 9384 Repair Type: No Action Needed Crossing Status: Found UCIP Comments: 5/2/2017 Crossing appears to be in good condition. (DWR Sutter Yard- AFreitag)10/17/2016 Crossing appears to be in good condition. (DWR Sutter Yard- AFreitag)5/31/2016 Crossing appears to be in good condition.5/4/2015 Crossing appears in good condition. No noticeable issues.6/17/2014 Same as last inspection.12/16/2013 Same as last inspection.7/16/2013 Same as last inspection. FIELD_STRUCT_DESC: 24-inch corrugated metal drainage pipe through the levee, 16 feet below the crown. Flap gate, concrete headwall, and grouted cobble spillway on the waterside (WS). Concrete headwall on the landside (LS). (24-inch pipe [HLM 3.22] authorized under Automatic Board Order (ABO) issued as Permit No. 9384, 1974 - William D. Struckmeyer) [Additional Reference(s): DWR Levee Log, 2005. USACE Sacramento O&M Manual 132, October 1959, (HLM 3.22)]. FS Date: 5/2/2017 2:04:40 PM

Concrete headwall and flap gate at WS toe.

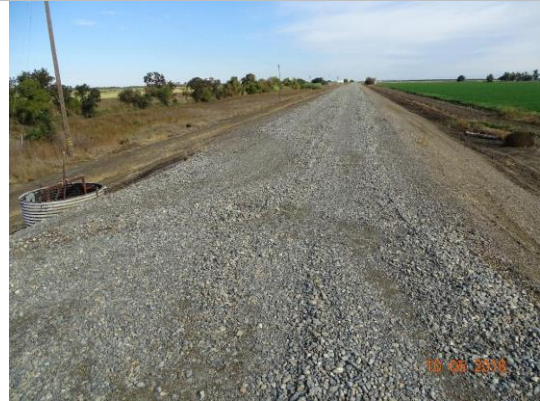
Photo 1 of 3 : UCIP_SP_2019_53011_78198.jpg

FS_ID:53011
DS_ID:17154
EP_NO: 9388
Repair Type: Non-Urgent
Crossing Status: Found
UCIP Comments: 10/5/2018 Fall hazard: missing cover on CMP riser. Closure devices are present on both ends of crossing and seem to be in operable condition. Downgraded to non-urgent. Recommend owner add cover to CMP riser. (O.Yakimov - DWR)5/2/2017 WS slidegate stem is still bent, wheel to operate gate is missing. Needs a cover made for the standpipe to prevent falls. (DWR Sutter Yard- AFreitag)10/17/2016 Slide gate stem is still and and the gate appears to be inoperable. (DWR Sutter Yard- AFreitag)5/31/2016 Slide gate stem is still bent. WS flap gate is chained open. (DWR Sutter Yard - afreitag)5/4/2015 Slide gate stem is still bent. Gate looks to be unable to close all the way. (DWR Sutter Yard - afreitag)6/17/2014 Same as last inspection. (DWR Sutter Yard - afreitag)12/16/2013 Slide gate stem is still bent. WS flapgate was closed. (DWR Sutter Yard - afreitag)7/16/2013 Water flowing through pipe so screw gate definately not closed. Was told NOV's have been sent for owner to replace stem. Flap gate gets closed for flood season. (DWR Sutter Yard - afreitag)10/11/2012 Slide gate inoperable, but appears to be in closed position. Flap gate held in open position. Good candidate for video inspection when, if ever, dry. (DWR UCIP - wwylie)

View of levee crown at crossing.

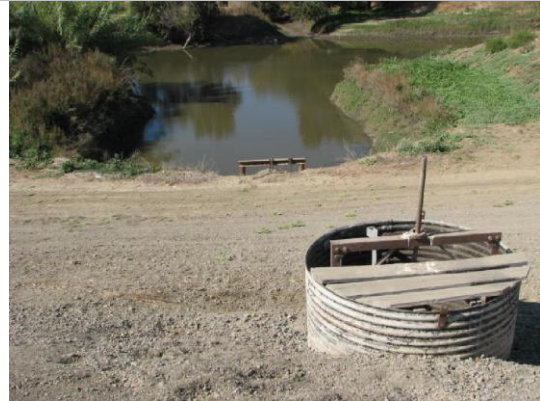
Photo 2 of 3 : UCIP_SP_2019_53011_69005.jpg

FS_ID:53011
DS_ID:17154
EP_NO: 9388
Repair Type: Non-Urgent
Crossing Status: Found
UCIP Comments: 10/5/2018 Fall hazard: missing cover on CMP riser. Closure devices are present on both ends of crossing and seem to be in operable condition. Downgraded to non-urgent. Recommend owner add cover to CMP riser. (O.Yakimov - DWR)5/2/2017 WS slidegate stem is still bent, wheel to operate gate is missing. Needs a cover made for the standpipe to prevent falls. (DWR Sutter Yard- AFreitag)10/17/2016 Slide gate stem is still and and the gate appears to be inoperable. (DWR Sutter Yard- AFreitag)5/31/2016 Slide gate stem is still bent. WS flap gate is chained open. (DWR Sutter Yard - afreitag)5/4/2015 Slide gate stem is still bent. Gate looks to be unable to close all the way. (DWR Sutter Yard - afreitag)6/17/2014 Same as last inspection. (DWR Sutter Yard - afreitag)12/16/2013 Slide gate stem is still bent. WS flapgate was closed. (DWR Sutter Yard - afreitag)7/16/2013 Water flowing through pipe so screw gate definately not closed. Was told NOV's have been sent for owner to replace stem. Flap gate gets closed for flood season. (DWR Sutter Yard - afreitag)10/11/2012 Slide gate inoperable, but appears to be in closed position. Flap gate held in open position. Good candidate for video inspection when, if ever, dry. (DWR UCIP - wwylie)

Slide gate in corrugated metal riser on WS slope.

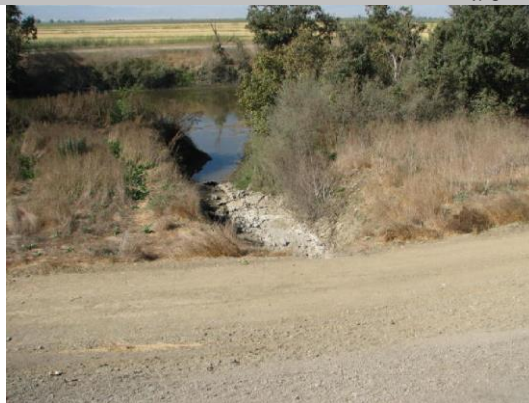
Photo 1 of 3 : UCIP_SP_2019_51791_69014.jpg

FS_ID:51791
DS_ID:17168
EP_NO: 9388
Repair Type: No Action Needed
Crossing Status: Found
UCIP Comments: 5/2/2017 Crossing appears to be in good condition.
(DWR Sutter Yard- AFreitag)10/17/2016 Crossing appears to be in good condition. (DWR Sutter Yard- AFreitag)5/31/2016 Crossing appears to be in good condition.5/4/2015 Corssing appears to be in good condition. No noticeable issues to report.6/17/2014 Same as last inspection.12/16/2013 Same as last inspection.7/16/2013 Same as last inspection.
FIELD_STRUCT_DESC: 36-inch corrugated metal drainage pipe through the levee, 27.5 feet below the crown. Flap gate, concrete headwall, and grouted cobble spillway located on the waterside (WS). Concrete headwall located on the landside (LS). (24-inch pipe [HLM 4.25] authorized under Automatic Board Order (ABO) issued as Permit No. 9388, 1974 - Pauline A. Wallace). [Additional Reference(s): DWR Levee Log, 2005. USACE Sacramento O&M Manual 132, October 1959, (HLM 4.25)].

Outlet at WS toe.

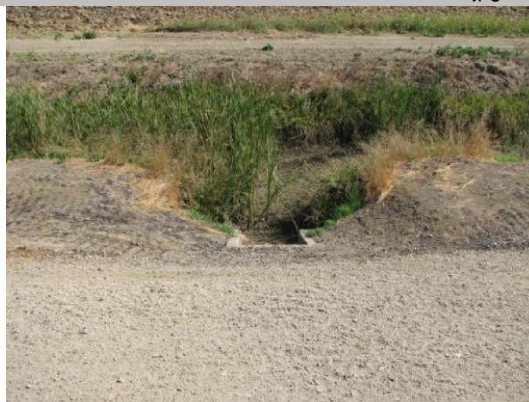
Photo 2 of 3 : UCIP_SP_2019_51791_69013.jpg

Concrete U shaped headwall on LS toe.

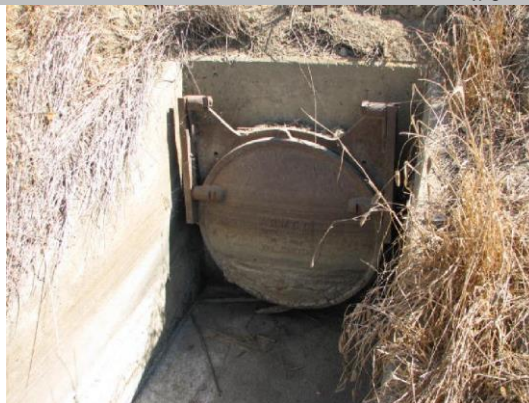
Photo 3 of 3 : UCIP_SP_2019_51791_69012.jpg

Comment Code						
Inspector Comment						
FS_ID:51791 DS_ID:17168 EP_NO: 9388 Repair Type: No Action Needed Crossing Status: Found UCIP Comments: 5/2/2017 Crossing appears to be in good condition. (DWR Sutter Yard- AFreitag)10/17/2016 Crossing appears to be in good condition. (DWR Sutter Yard- AFreitag)5/31/2016 Crossing appears to be in good condition.5/4/2015 Corssing appears to be in good condition. No noticeable issues to report.6/17/2014 Same as last inspection.12/16/2013 Same as last inspection.7/16/2013 Same as last inspection. FIELD_STRUCT_DESC: 36-inch corrugated metal drainage pipe through the levee, 27.5 feet below the crown. Flap gate, concrete headwall, and grouted cobble spillway located on the waterside (WS). Concrete headwall located on the landside (LS). (24-inch pipe [HLM 4.25] authorized under Automatic Board Order (ABO) issued as Permit No. 9388, 1974 - Pauline A. Wallace). [Additional Reference(s): DWR Levee Log, 2005. USACE Sacramento O&M Manual 132, October 1959, (HLM 4.25)]. FS Date: 5/2/2017 2:08:40 PM

Concrete U shaped headwall and flap gate on WS toe.

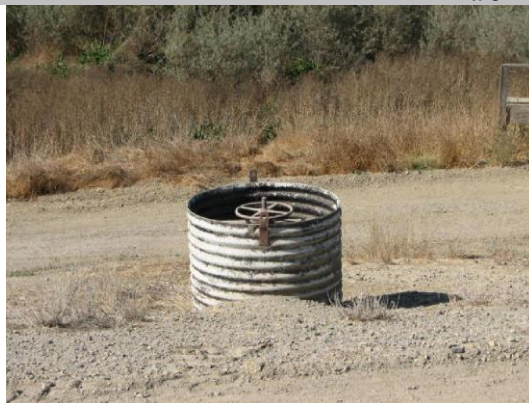
Photo 3 of 3 : UCIP_SP_2019_51792_69015.jpg

Comment Code						
Inspector Comment						
FS_ID:51792						
DS_ID:17156						
EP_NO: 9388						
Repair Type: No Action Needed						
Crossing Status: Found						
UCIP Comments: 5/2/2017 Crossing appears to be in good condition. (DWR Sutter Yard- AFreitag)10/17/2016 Crossing appears to be in good condition. (DWR Sutter Yard- AFreitag)5/31/2016 Crossing appears to be in good condition.5/4/2015 Corssing appears to be in good condition. No noticeable issues to report.6/17/2014 Same as last inspection.12/16/2013 Same as last inspection.7/16/2013 Same as last inspection.						
FIELD_STRUCT_DESC: 24-inch corrugated metal drainage pipe through the levee, 9.2 feet below the crown. Slide gate in a 36-inch corrugated metal pipe (CMP) riser on the waterside (WS) slope. Pump on a 60-inch concrete standpipe at the landside (LS) toe. (24-inch pipe [HLM 4.32] authorized under Automatic Board Order (ABO) issued as Permit No. 9388, 1974 - Pauline A. Wallace). [Additional Reference(s): DWR Levee Log, 2005. USACE Sacramento O&M Manual 132, October 1959, (HLM 4.32)].

36-inch CMP riser with Slide gate on WS shoulder.

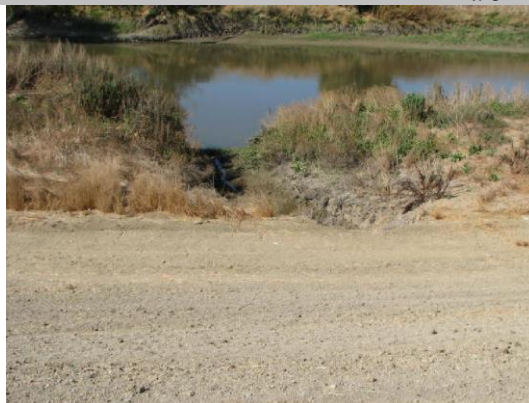
Photo 1 of 3 : UCIP_SP_2019_51795_69026.jpg

FS_ID:51795
DS_ID:17158
EP_NO: 9390
Repair Type: No Action Needed
Crossing Status: Found
UCIP Comments: 5/2/2017 Crossing appears to be in good condition. There is minor sediment build up in front of the WS flap gate/ (DWR Sutter Yard- A Freitag) 10/17/2016 Crossing appears to be in good condition. (DWR Sutter Yard- A Freitag) 5/31/2016 Crossing appears to be in good condition. 5/4/2015 Crossing appears to be in good condition. No noticeable issues to report. 6/17/2014 Same as last inspection. 12/16/2013 Same as last inspection. 7/16/2013 New flapgate installed on WS pipe end. 10/11/2012 Flap gate broken on WS, Pipe shows significant rust at outlet. This is a good candidate for video inspection.
FIELD_STRUCT_DESC: 36-inch corrugated metal drainage pipe through the levee, 20 feet below the crown. Pump on metal pier in landside (LS) channel. 40-inch steel standpipe at the LS toe. Flap gate and concrete headwall on the waterside (WS). Concrete headwall on the LS. (36-inch pipe authorized under Automatic Board Order (ABO) issued as Permit No. 9390, 1974 - Annie D. Propfe). [Additional Reference(s): DWR Levee Log, 2005. USACE Sacramento O&M Manual 132, October 1959, (HLM 4.87)].

Outlet channel on WS toe.

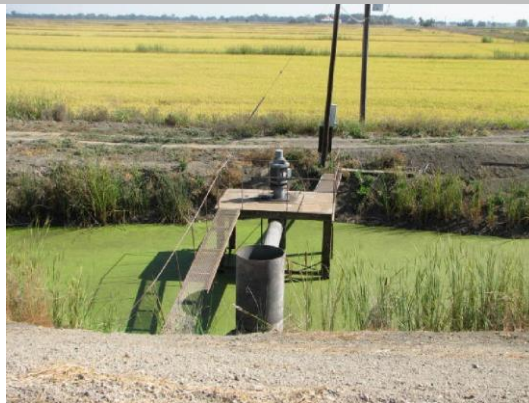
Photo 2 of 3 : UCIP_SP_2019_51795_69025.jpg

Pump, walkway, and standpipe on LS toe.

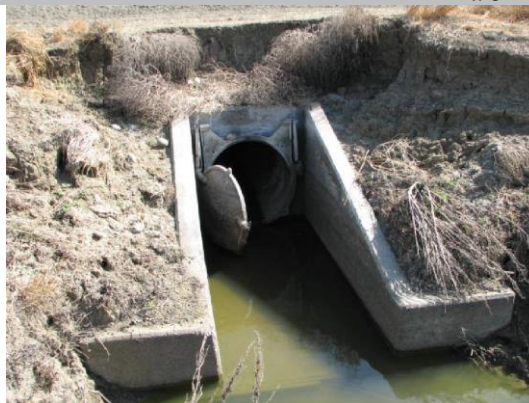
Photo 3 of 3 : UCIP_SP_2019_51795_69024.jpg

Comment Code						
Inspector Comment						
FS_ID:51795 DS_ID:17158 EP_NO: 9390 Repair Type: No Action Needed Crossing Status: Found UCIP Comments: 5/2/2017 Crossing appears to be in good condition. There is minor sediment build up in front of the WS flap gate/ (DWR Sutter Yard- A Freitag)10/17/2016 Crossing appears to be in good condition. (DWR Sutter Yard- A Freitag)5/31/2016 Crossing appears to be in good condition.5/4/2015 Corssing appears to be in good condition. No noticeable issues to report.6/17/2014 Same as last inspection.12/16/2013 Same as last inspection.7/16/2013 New flapgate installed on WS pipe end.10/11/2012 Flap gate broken on WS, Pipe shows significant rust at outlet. This is a good candidate for video inspection. FIELD_STRUCT_DESC: 36-inch corrugated metal drainage pipe though the levee, 20 feet below the crown. Pump on metal pier in landside (LS) channel. 40-inch steel standpipe at the LS toe. Flap gate and concrete headwall on the waterside (WS). Concrete headwall on the LS. (36-inch pipe authorized under Automatic Board Order (ABO) issued as Permit No. 9390, 1974 - Annie D. Propfe). [Additional Reference(s): DWR Levee Log, 2005. USACE Sacramento O&M Manual 132, October 1959, (HLM 4.87)]. FS Date: 5/2/2017 2:30:31 PM

Flap gate in concrete U-shaped headwall on WS toe.

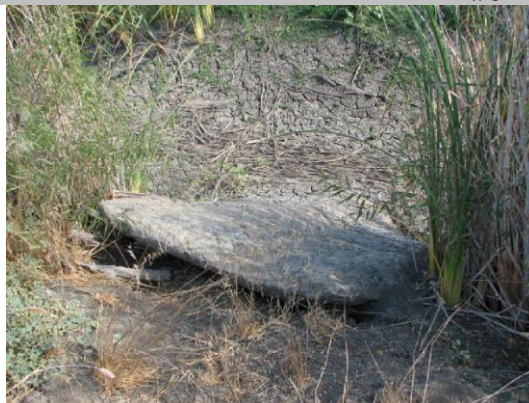
Photo 1 of 3 : UCIP_SP_2019_51796_69030.jpg

Comment Code						
Inspector Comment						
FS_ID:51796 DS_ID:17191 EP_NO: N/A Repair Type: Non-Urgent Crossing Status: Found UCIP Comments: 5/2/2017 WS headwall and flapgate almost completely buried with only a small portion of the head wall visible. LS end is buried and unable to be located. (DWR Sutter Yard-AFreitag)10/17/2016 WS flap gate is still silted over and LS inlet is heavily vegetated and unable to be inspected. (DWR Sutter Yard-AFreitag)9/29/2016 Crosssing has been downgraded from Urgent to Non-Urgent WS flap gate is closed shut due to sediment build up. For flood season flap gate is required to be closed. Need to coordinate with owner to remove sediment from WS to have WS flap gate be operable after flood season. (DWR UCIP - omagana)5/31/2016 WS pipe end was mostly underwater but it appears to still be silted over. (DWR Sutter Yard - afreitag)5/4/2015 WS flapgate is blocked by sediment and unable to open. LS inlet is hidden by sediment and heavy vegetation and unable to be located. Needs to be cleared. (DWR Sutter Yard - afreitag)6/17/2014 Same as last inspection. (DWR Sutter Yard - afreitag)12/16/2013 Same as last inspection. (DWR Sutter Yard - afreitag)7/16/2013 Same as last inspection. (DWR Sutter Yard - afreitag)10/11/2012 Pipe is clogged at both the inlet and outlet. Good candidate for video inspection. (DWR UCIP - wwylie) FIELD_STRUCT_DESC: 48-inch corrugated metal drainage pipe through the levee, approximately 15 feet below the crown. Concrete headwalls on both the waterside (WS) and the landside (LS) ends with an automatic drainage gate on the WS. [Additional Reference(s): USACE Sacramento O&M Manual 132, October 1959, (HLM 5.12)]. FS Date: 5/2/2017 2:31:39 PM

Apparent inlet clogged with concrete or grout on LS toe in drainage swale.

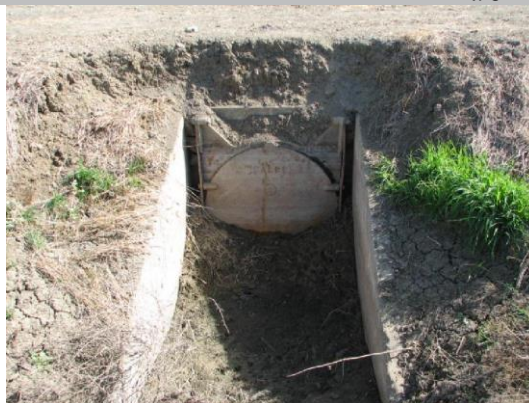
Photo 3 of 3 : UCIP_SP_2019_51796_69028.jpg

Comment Code						
Inspector Comment						
FS_ID:51796 DS_ID:17191 EP_NO: N/A Repair Type: Non-Urgent Crossing Status: Found UCIP Comments: 5/2/2017 WS headwall and flapgate almost completely buried with only a small portion of the head wall visible. LS end is buried and unable to be located. (DWR Sutter Yard-AFreitag)10/17/2016 WS flap gate is still silted over and LS inlet is heavily vegetated and unable to be inspected. (DWR Sutter Yard-AFreitag)9/29/2016 Crosssing has been downgraded from Urgent to Non-Urgent WS flap gate is closed shut due to sediment build up. For flood season flap gate is required to be closed. Need to coordinate with owner to remove sediment from WS to have WS flap gate be operable after flood season. (DWR UCIP - omagana)5/31/2016 WS pipe end was mostly underwater but it appears to still be silted over. (DWR Sutter Yard - afreitag)5/4/2015 WS flapgate is blocked by sediment and unable to open. LS inlet is hidden by sediment and heavy vegetation and unable to be located. Needs to be cleared. (DWR Sutter Yard - afreitag)6/17/2014 Same as last inspection. (DWR Sutter Yard - afreitag)12/16/2013 Same as last inspection. (DWR Sutter Yard - afreitag)7/16/2013 Same as last inspection. (DWR Sutter Yard - afreitag)10/11/2012 Pipe is clogged at both the inlet and outlet. Good candidate for video inspection. (DWR UCIP - wwylie) FIELD_STRUCT_DESC: 48-inch corrugated metal drainage pipe through the levee, approximately 15 feet below the crown. Concrete headwalls on both the waterside (WS) and the landside (LS) ends with an automatic drainage gate on the WS. [Additional Reference(s): USACE Sacramento O&M Manual 132, October 1959, (HLM 5.12)]. FS Date: 5/2/2017 2:31:39 PM

Concrete U shaped headwall and flap gate on WS toe.

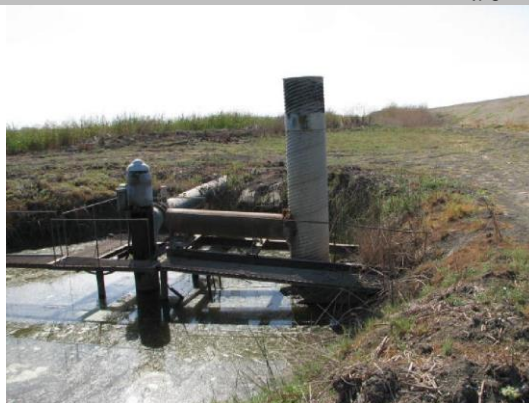
Photo 1 of 3 : UCIP_SP_2019_51797_69034.jpg

Comment Code						
Inspector Comment						
FS_ID:51797 DS_ID:17190 EP_NO: N/A Repair Type: No Action Needed Crossing Status: Found UCIP Comments: 5/2/2017 Crossing appears to be in good condition. (DWR Sutter Yard- AFreitag)10/17/2016 Crossing appears to be in good condition. Pipe was field verified to be 48inch cmp. (DWR Sutter Yard- AFreitag)5/31/2016 Crossing appears to be in good condition.5/4/2015 Corssing appears to be in good condition. No noticeable issues to report.6/17/2014 Same as last inspection.12/16/2013 Same as last inspection.7/16/2013 Same as last inspection. FIELD_STRUCT_DESC: 48-inch corrugated metal drainage pipe through the levee, approximately 22 feet below the crown. Concrete headwalls at both the waterside (WS) and the landside (LS) ends with flap gate on the WS. 36-inch corrugated metal pipe (CMP) riser on the LS toe with steel pipe extension for overflow weir of LS ditch. Walkway and pump not associated with this crossing. (Automatic board order (ABO) issued as Permit No. 8234, 1972 - Glenn Irrigation District, for 36-inch, not 48-inch). [Additional Reference(s): USACE Sacramento O&M Manual 132, October 1959, (HLM 6.04, Drawing No. 50-4-3081, Sheet 16)]. FS Date: 5/2/2017 2:33:13 PM

36-inch CM standpipe with steel pipe extension for weir on LS toe.
pump not associated with storm drain crossing.

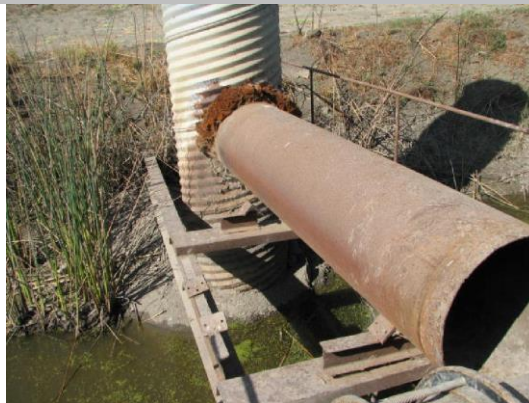
Photo 2 of 3 : UCIP_SP_2019_51797_69033.jpg

36-inch CM standpipe with steel pipe extension for weir on LS toe.

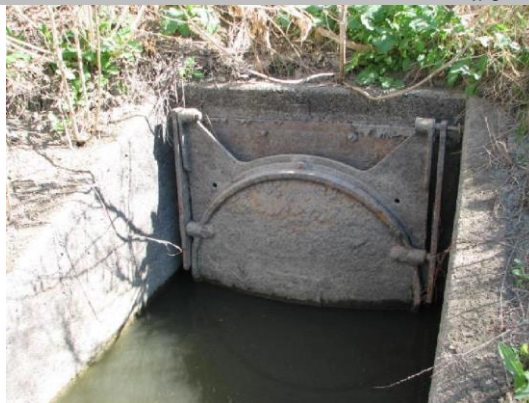
Photo 3 of 3 : UCIP_SP_2019_51797_69032.jpg

Comment Code						
Inspector Comment						
FS_ID:51797						
DS_ID:17190						
EP_NO: N/A						
Repair Type: No Action Needed						
Crossing Status: Found						
UCIP Comments: 5/2/2017 Crossing appears to be in good condition. (DWR Sutter Yard- AFreitag)10/17/2016 Crossing appears to be in good condition. Pipe was field verified to be 48inch cmp. (DWR Sutter Yard- AFreitag)5/31/2016 Crossing appears to be in good condition.5/4/2015 Corssing appears to be in good condition. No noticeable issues to report.6/17/2014 Same as last inspection.12/16/2013 Same as last inspection.7/16/2013 Same as last inspection.						
FIELD_STRUCT_DESC: 48-inch corrugated metal drainage pipe through the levee, approximately 22 feet below the crown. Concrete headwalls at both the waterside (WS) and the landside (LS) ends with flap gate on the WS. 36-inch corrugated metal pipe (CMP) riser on the LS toe with steel pipe extension for overflow weir of LS ditch. Walkway and pump not associated with this crossing. (Automatic board order (ABO) issued as Permit No. 8234, 1972 - Glenn Irrigation District, for 36-inch, not 48-inch). [Additional Reference(s): USACE Sacramento O&M Manual 132, October 1959, (HLM 6.04, Drawing No. 50-4-3081, Sheet 16)].

Flap gate in concrete U-shaped headwall at WS toe.

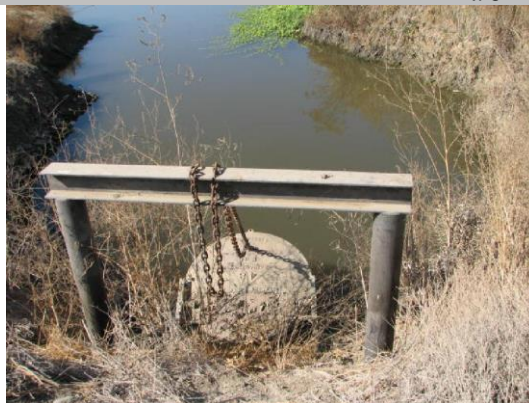
Photo 1 of 3 : UCIP_SP_2019_51798_69042.jpg

FS_ID:51798
DS_ID:17161
EP_NO: 9390
Repair Type: No Action Needed
Crossing Status: Found
UCIP Comments: 5/2/2017 Crossing appears to be in good condition.
(DWR Sutter Yard- AFreitag)10/17/2016 Crossing appears to be in good condition. (DWR Sutter Yard- AFreitag)5/31/2016 Crossing appears to be in good condition.5/4/2015 Corssing appears to be in good condition. No noticeable issues to report.6/17/2014 Same as last inspection.12/16/2013 Same as last inspection.7/16/2013 Same as last inspection.
FIELD_STRUCT_DESC: 48-inch corrugated metal drainage pipe through the levee, 20.3 feet below the crown. Concrete headwall and cobble revetted spillway on the waterside (WS). Slide gate in a 60-inch corrugated metal pipe (CMP) riser on the WS slope. Concrete headwall located on the landside (LS). (48-inch pipe authorized under Automatic Board Order (ABO) issued as Permit No. 9390, 1974 - Annie D. Propfe). [Additional Reference(s): DWR Levee Log, 2005. USACE Sacramento O&M Manual 132, October 1959, (HLM 6.10)].

48-inch flap gate on WS toe.

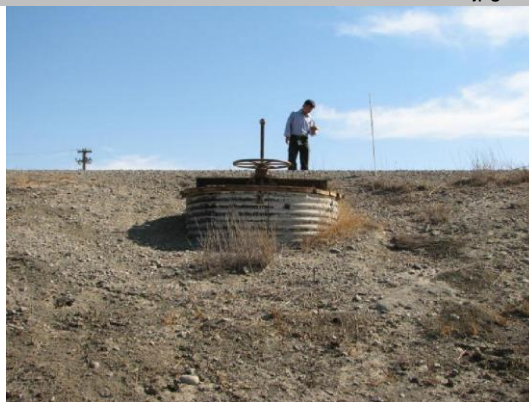
Photo 2 of 3 : UCIP_SP_2019_51798_69041.jpg

60-inch CMP riser with slide gate on WS slope.

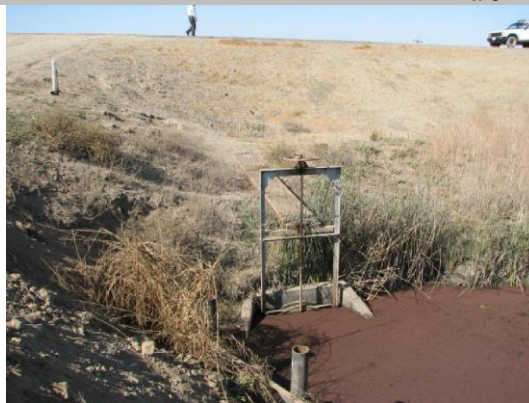
Photo 3 of 3 : UCIP_SP_2019_51798_69040.jpg

Concrete headwall with slide gate at LS toe.

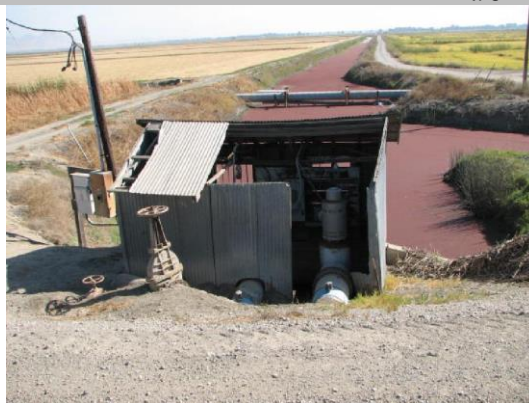
Photo 1 of 3 : UCIP_SP_2019_51803_69081.jpg

Pump house on LS slope.

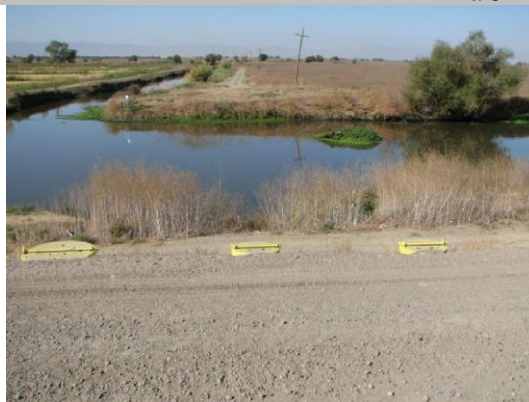
Photo 2 of 3 : UCIP_SP_2019_51803_69080.jpg

Siphon breaker on WS shoulder.

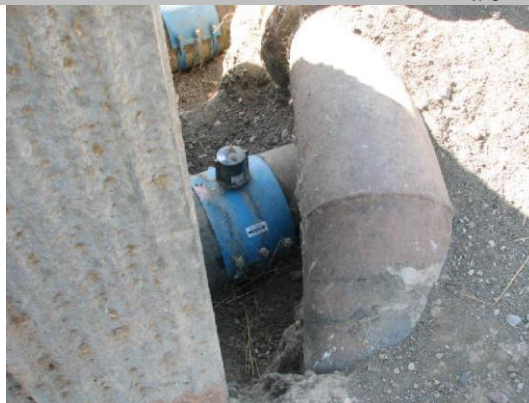
Photo 3 of 3 : UCIP_SP_2019_51803_69079.jpg

Pipe at exit from pumphouse.

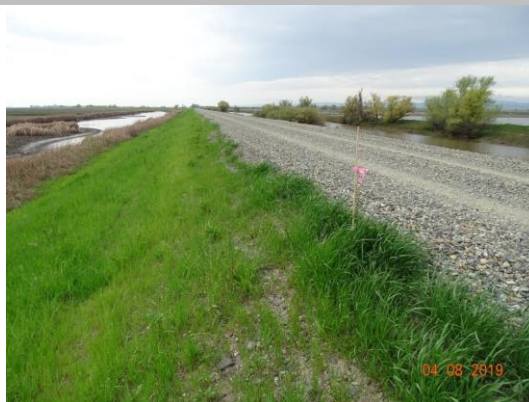
Photo 1 of 1 : SP_2019_MA0012_299_2_20190415_00077.jpg

View of the sloughing on the landside slope. Spring 2019.

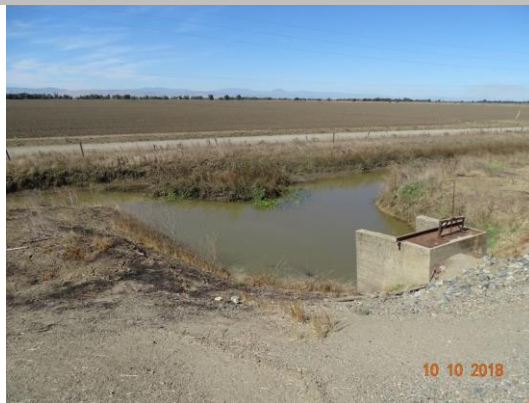
Photo 1 of 2 : SP_2019_MA0012_299_35_20190304_00004.jpg

View of diversion structure. Fall 2018.

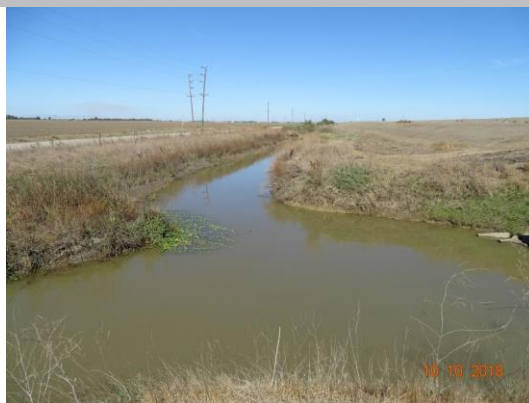
Photo 2 of 2 : SP_2019_MA0012_299_35_20190304_00005.jpg

Upstream view of Colusa Basin from the diversion structure. Fall 2018.

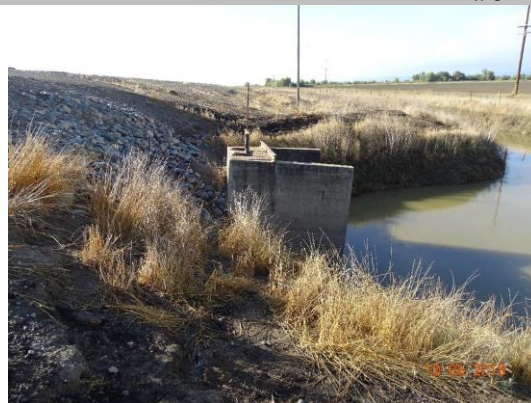
Photo 1 of 3 : UCIP_SP_2019_53012_78206.jpg

Headwall at WS toe.

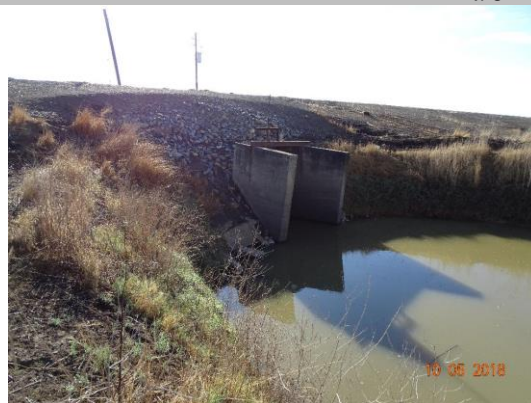
Photo 2 of 3 : UCIP_SP_2019_53012_78208.jpg

Overview of headwall at WS toe.

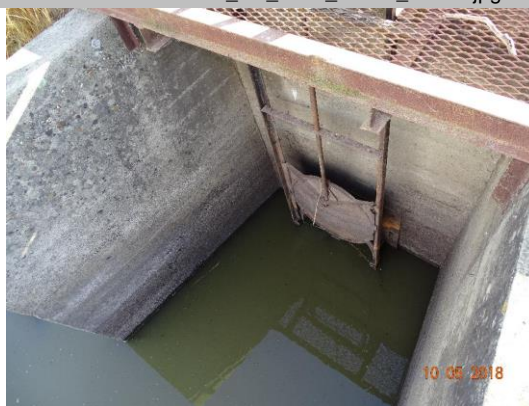
Photo 3 of 3 : UCIP_SP_2019_53012_78209.jpg

Inside view of concrete headwall and slidegate at WS toe.

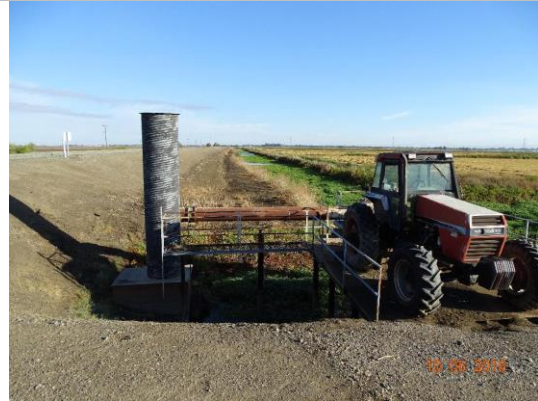
Photo 1 of 3 : UCIP_SP_2019_53013_78165.jpg

Pumping plant at LS toe.

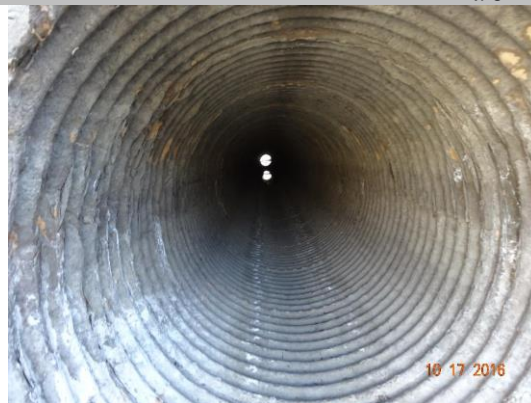
Photo 2 of 3 : UCIP_SP_2019_53013_76060.jpg

View inside of pipe from the WS

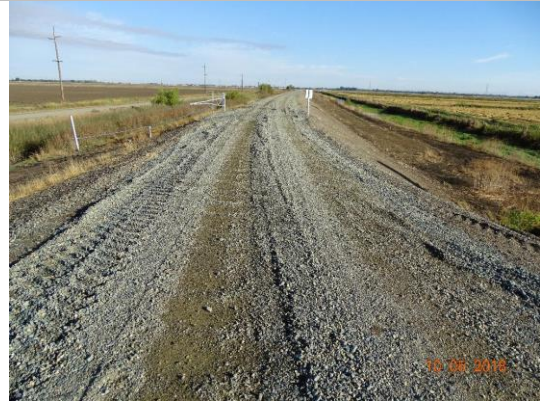
Photo 3 of 3 : UCIP_SP_2019_53013_78159.jpg

View of levee crown at crossing.

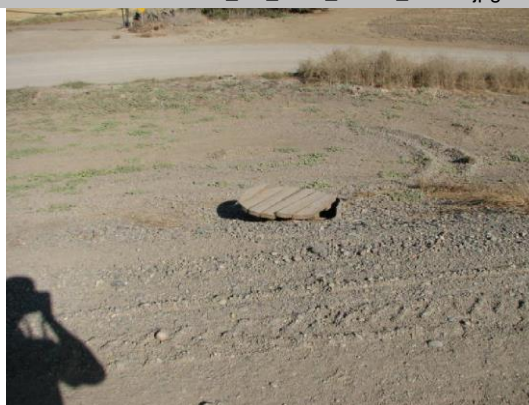
Photo 1 of 2 : UCIP_SP_2019_51810_69115.jpg

cover on 36-inch CMP standpipe on WS slope.

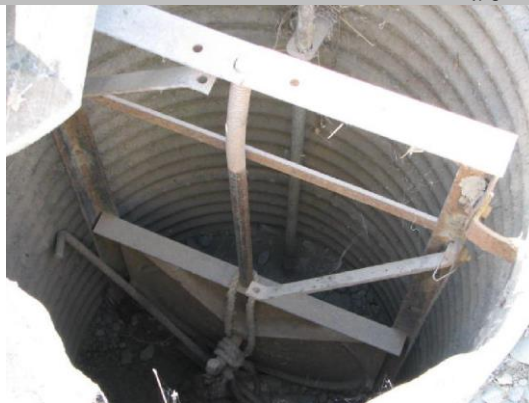
Photo 2 of 2 : UCIP_SP_2019_51810_69114.jpg

Bent and broken actuator on slide gate in 36-inch CMP. Pipe appears to be filled with soil.
